**AIR FORCE FLIGHT DYNAMICS LABORATORY  
DIRECTOR OF LABORATORIES  
AIR FORCE SYSTEMS COMMAND  
WRIGHT PATTERSON AIR FORCE BASE OHIO**

**Crack Propagation Test Results for Variable  
Amplitude Spectrum Loading in Surface Flawed D6ac Steel**

Technical Memorandum FBR-71-2

February 1971

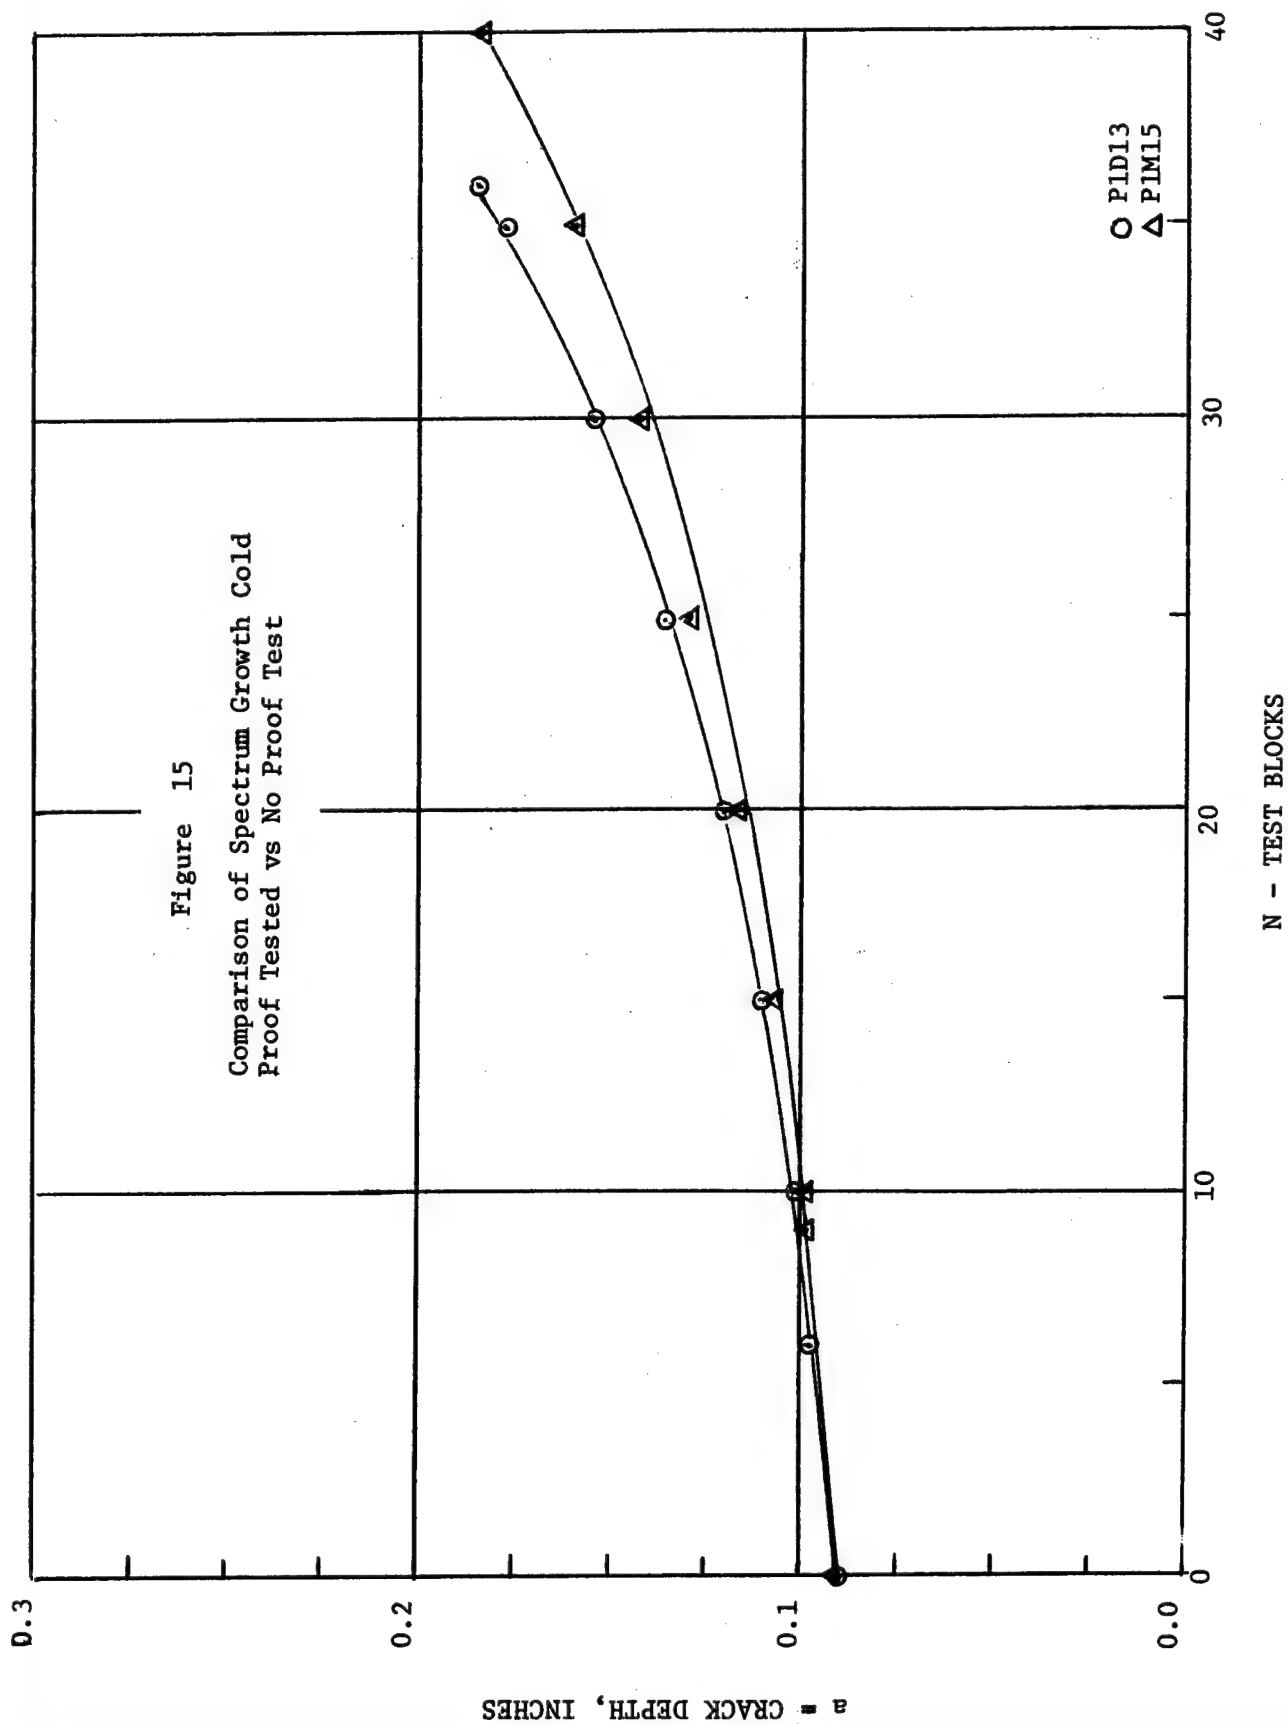
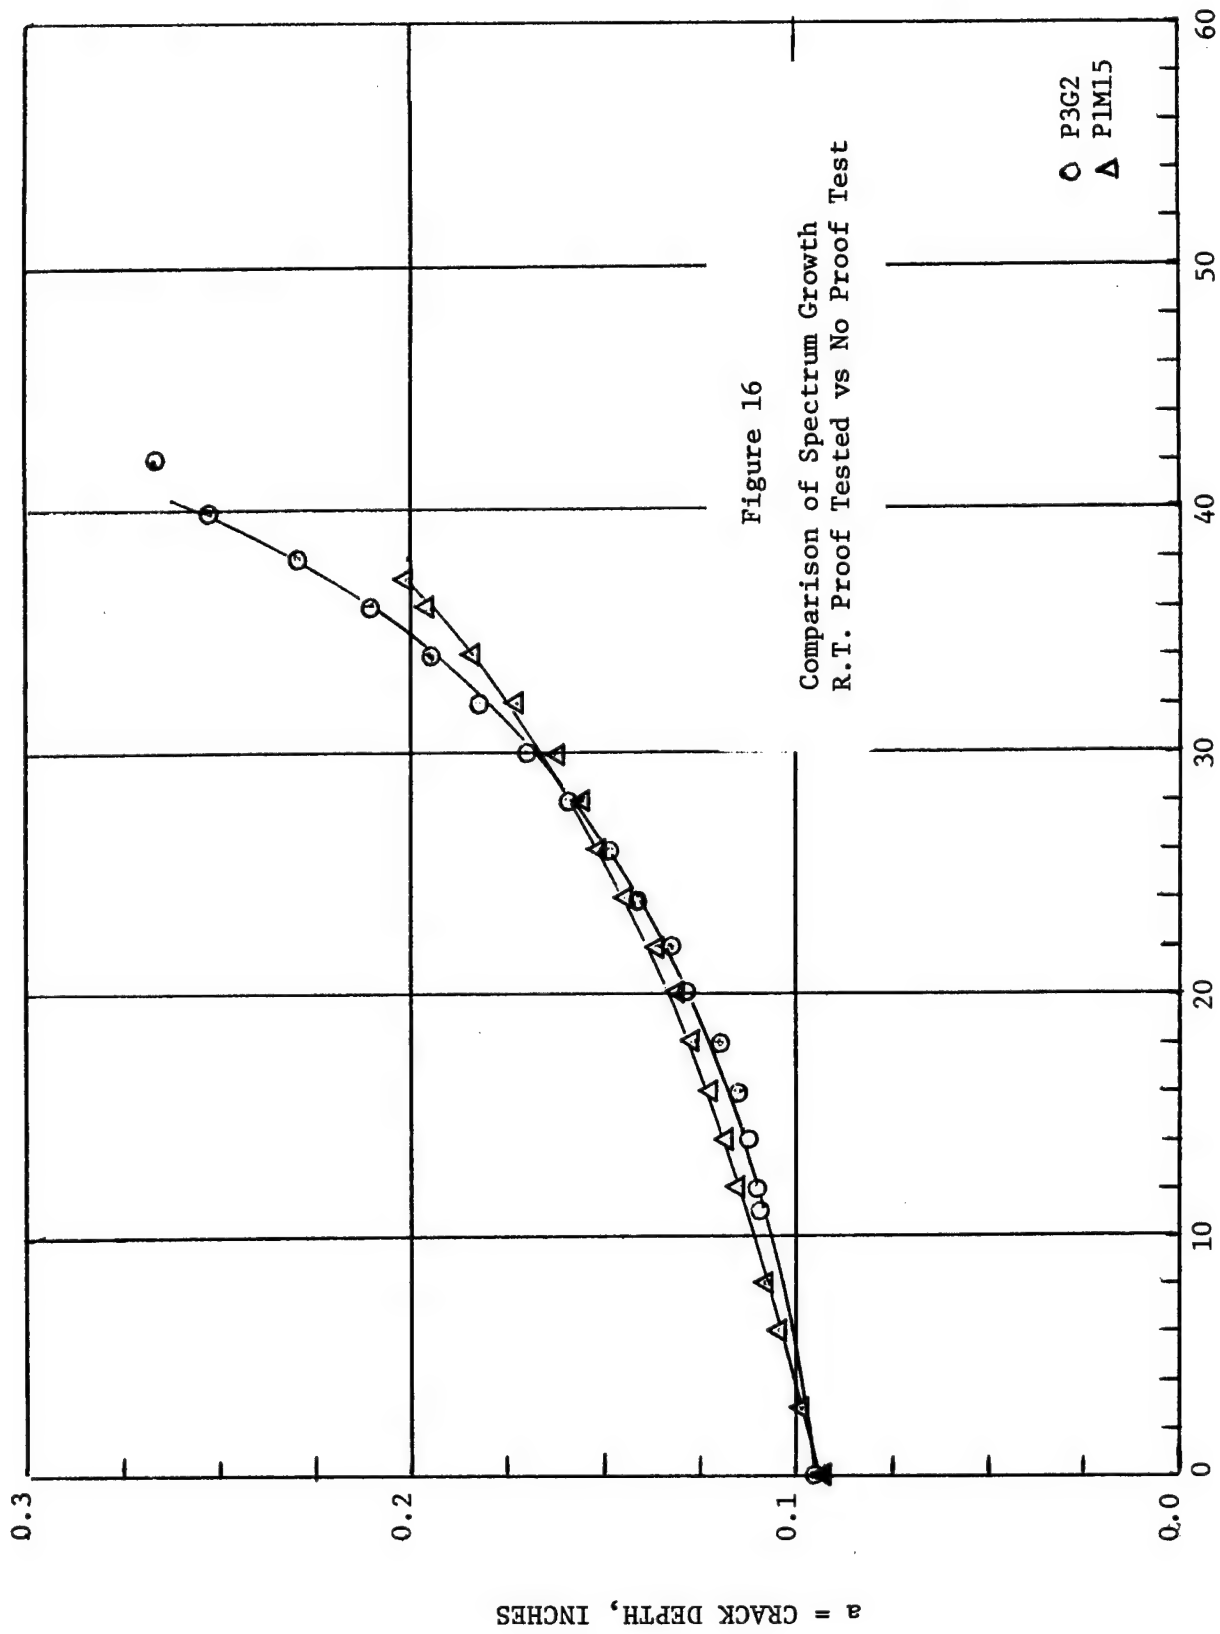
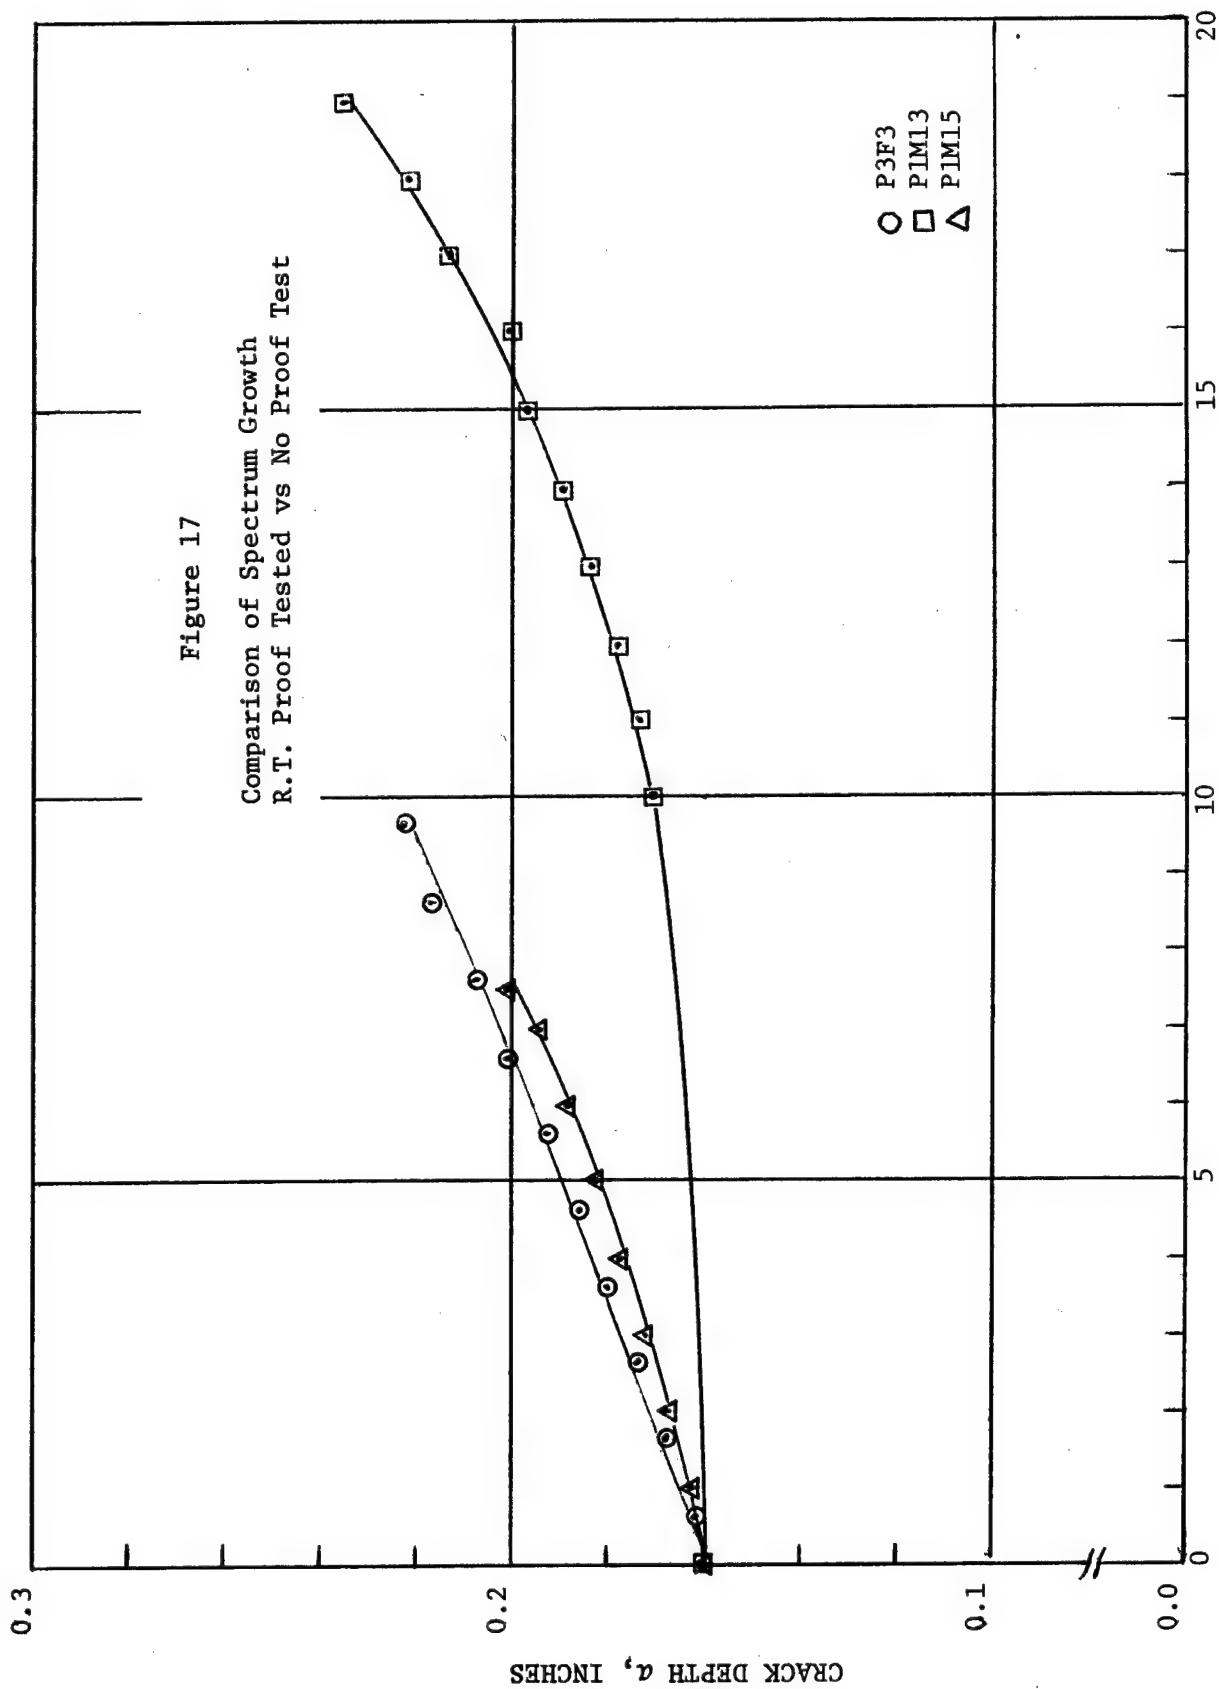
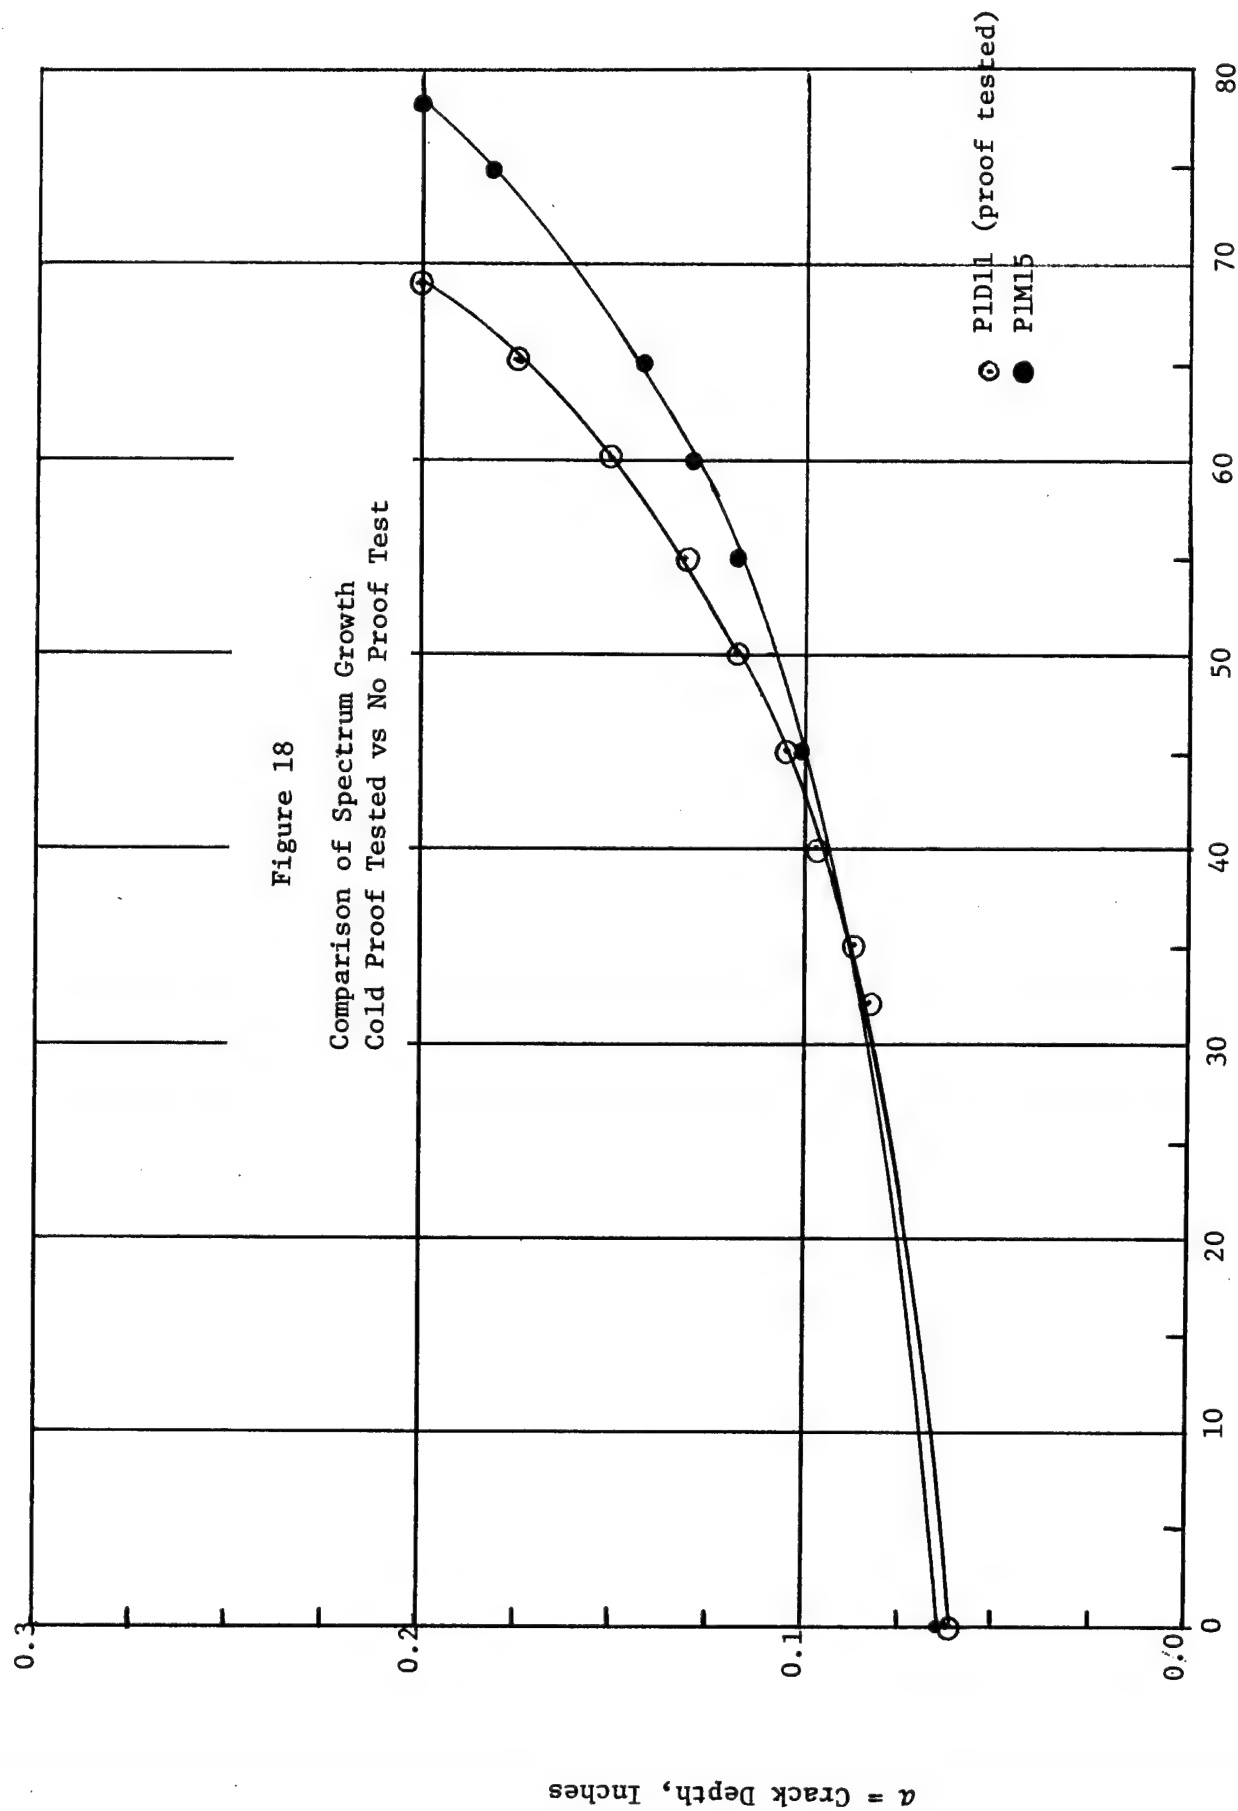
With the exception of specimen PLM13, no marked delay in crack growth was evident due to the prior application of the limit stress proof test. Comparative plots of the data have been included in Figures 15-18. Using fracture surface measurements, the approximate level of  $K_p$ , the estimated stress intensity for the proof stress application was determined. These results have been included in Table II. The results for PLM13 indicate the level of  $K_p$  higher than any other proof tested specimen. In fact, the reported results in Table II reveal a level greater than either  $K_Q$  or  $K_{IC}$ . This phenomenon may be attributed to stable growth during the proof test

N - TEST BLOCKS

N - TEST BLOCKS AFTER  $a = 0.160$

N - Total Test Blocks

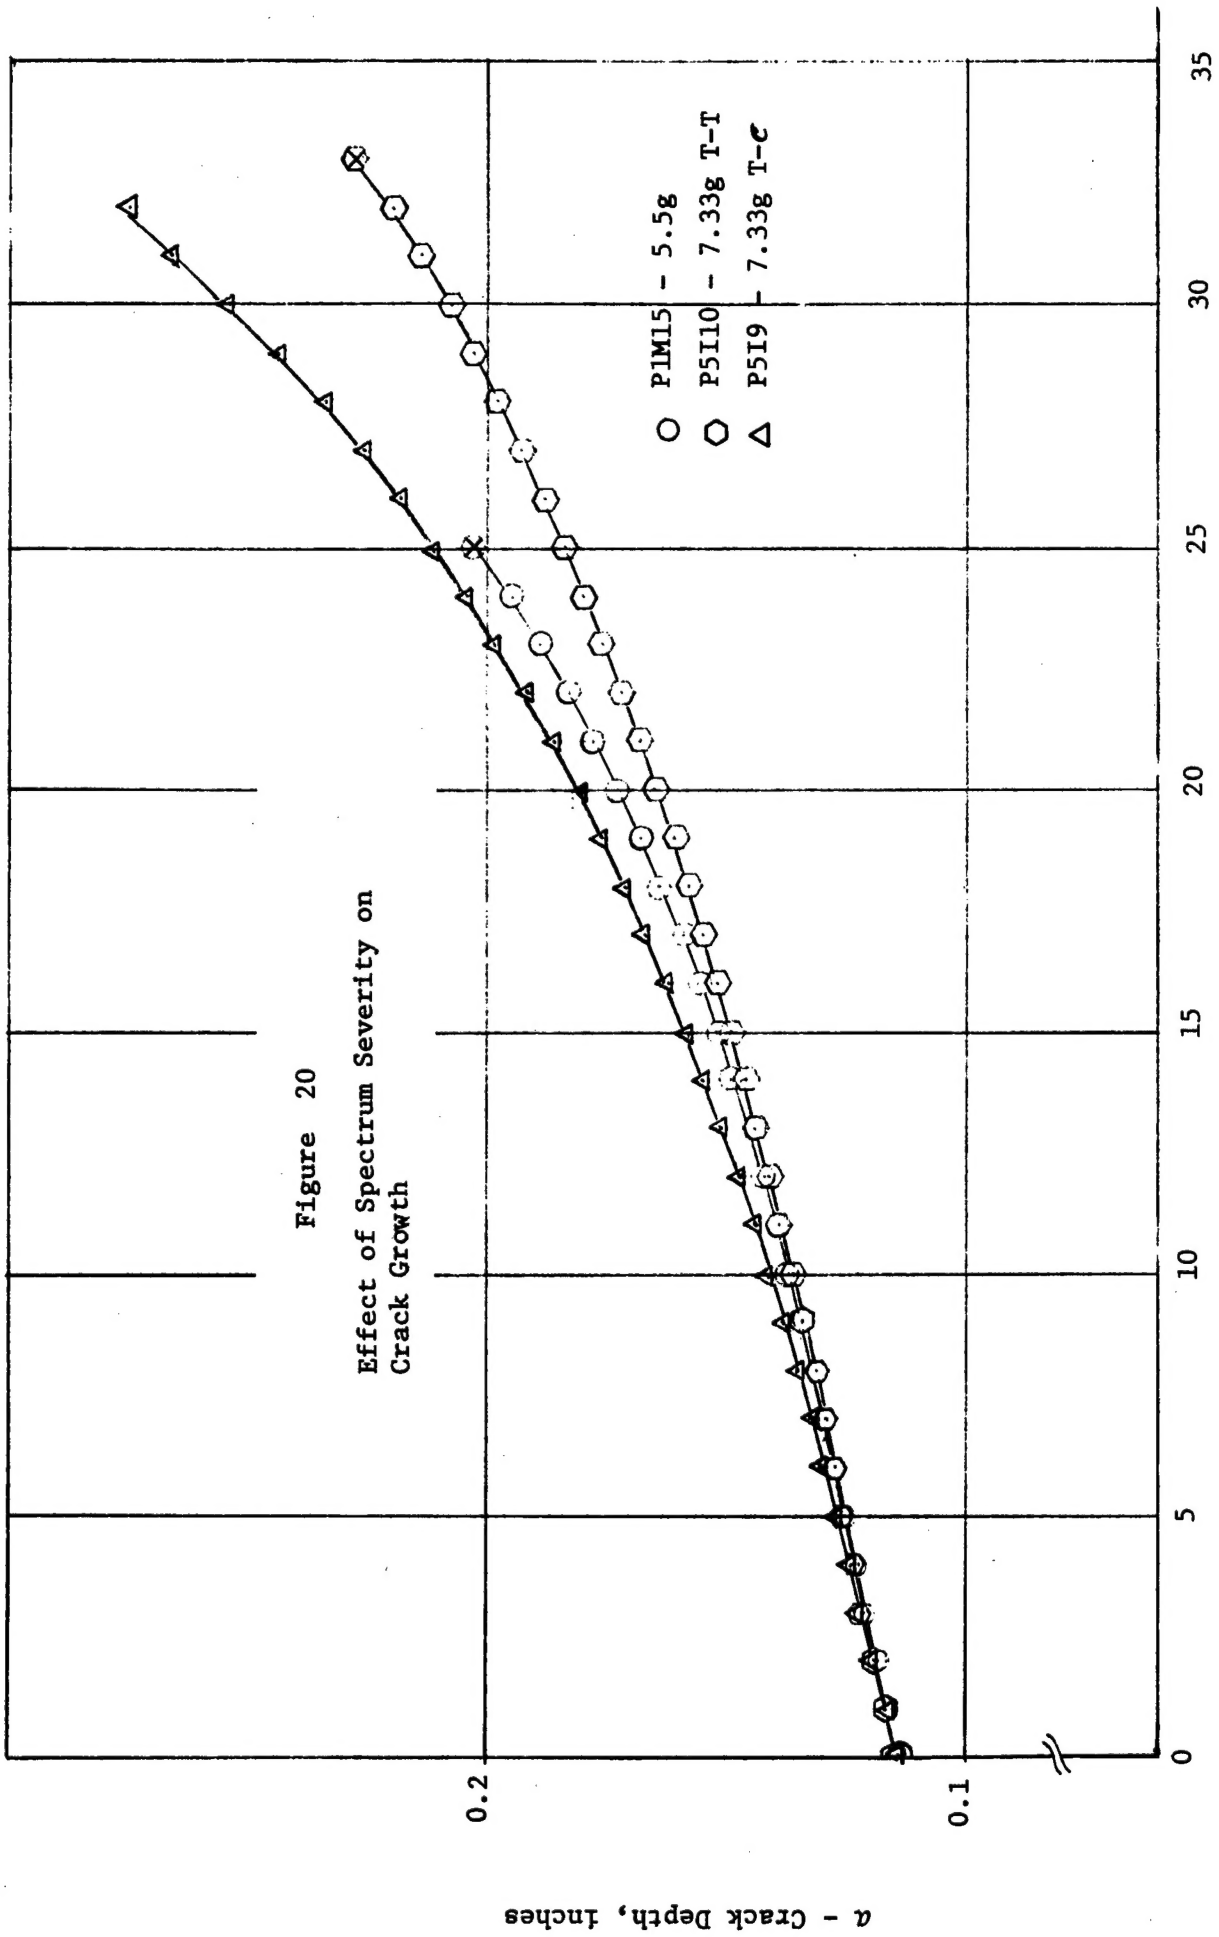
The effects of spectrum severity and limited compression may be seen in Figure 20 where the results of PLM15 have been compared with P5I10 (7.33g T-T) and P5I9 (7.33g T-C). For the particular ordering of the test spectrum used in this program, the occurrences of high stress in the 7.33g spectrum appear to have a retarding effect. Limited compression caused a more rapid growth; however, the results of P5I9 fall within the scatter of the 5g spectrum.

N - Test Block After  $a = 0.114$  in.
